# Inspection Report

Todd Shafer  
13190 Kaufman Ave.  
Hartville, Ohio

**CAPSTONE INSPECTIONS, LLC**

Date of Inspection: January 25th. 2010

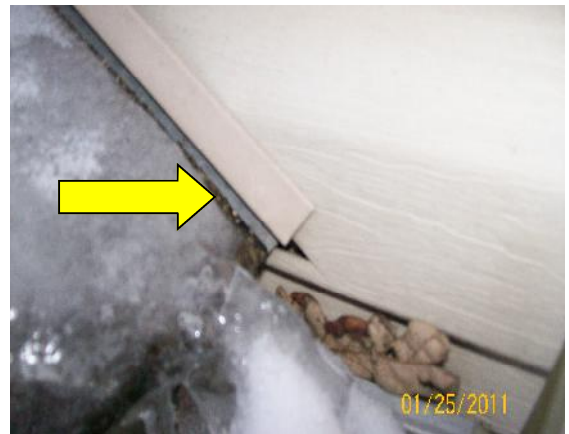
Here is a second photo of the exposed flashing. This should be repaired to prevent water damage.

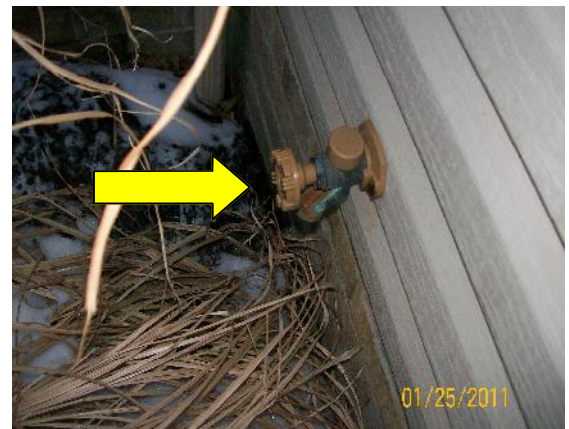
The property has several exterior spigots that are all frost free. The exterior water is turned off, but they seem to be in good condition.

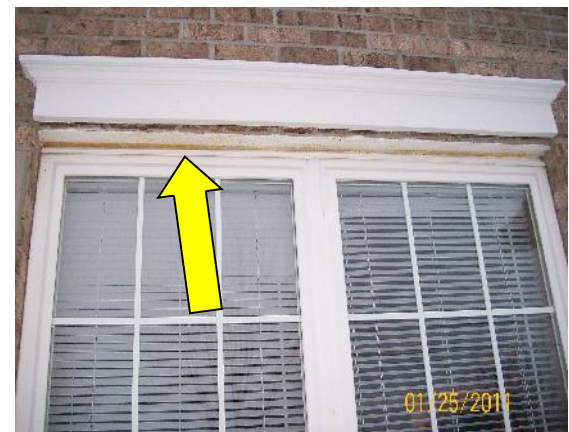
The steel header above the large window in the front of the home should be painted. It is showing signs of rust.

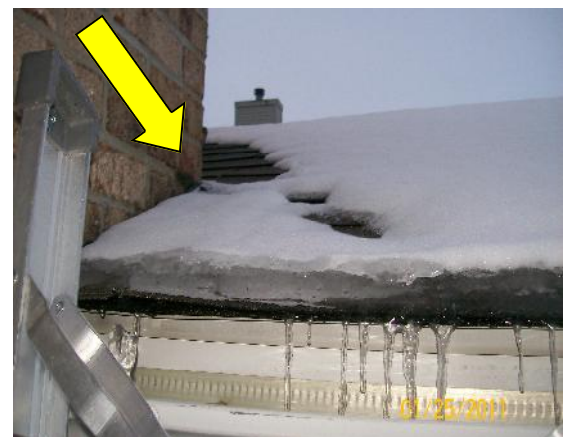
Here is another ice dam. There is also evidence of home owner repair. The use of roofing tar against the home where the shingles meet and around the corner are evidence of water intrusion.

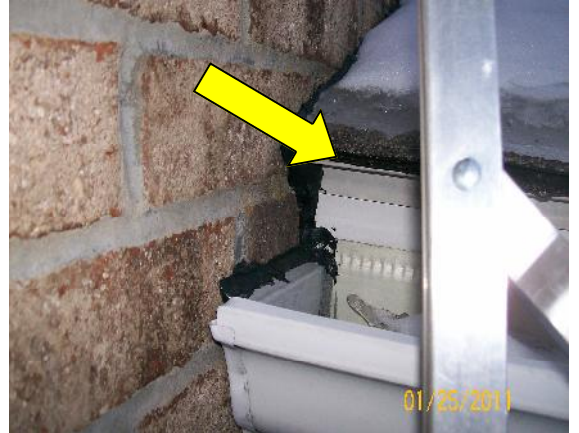
When the roof shingles were installed they were not hung over to allow the rain water to drip into the gutter. This can cause water to get behind the shingles. This should be sealed and maintained.

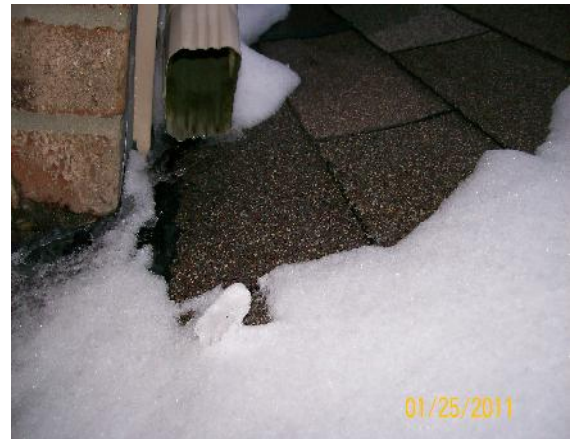
This is a big problem that needs to be repaired. The water from another section of the roof is dumping on the lower roof. Shingles were not designed to stop this much water. If this is not leaking now it will.

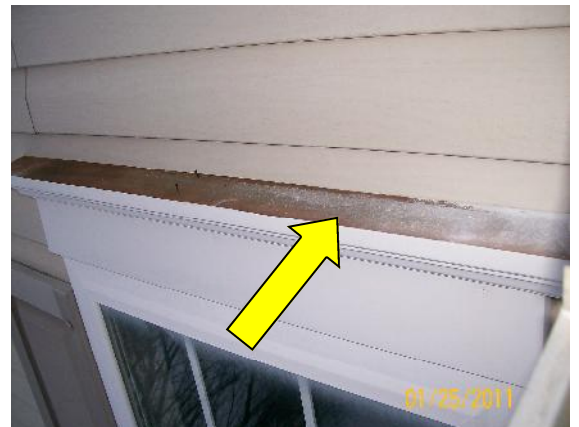
Another section of the window top was not painted. This should be painted to protect from water.

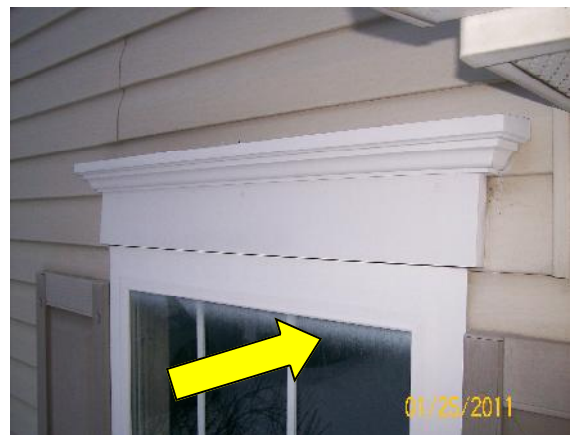
The white ash like substance is where the paint used is washing off and on to the window.

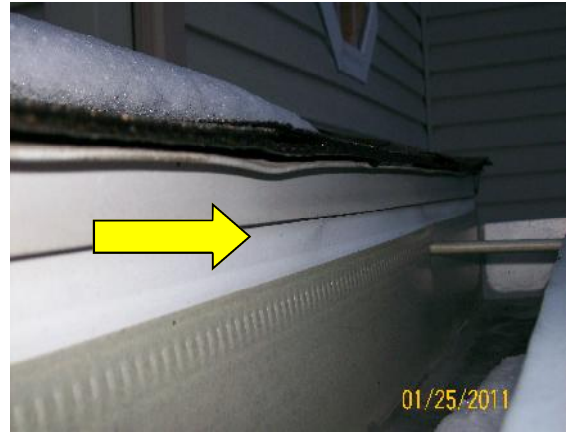
The roof does have a drip edge, but the shingles are short and not hanging over enough.

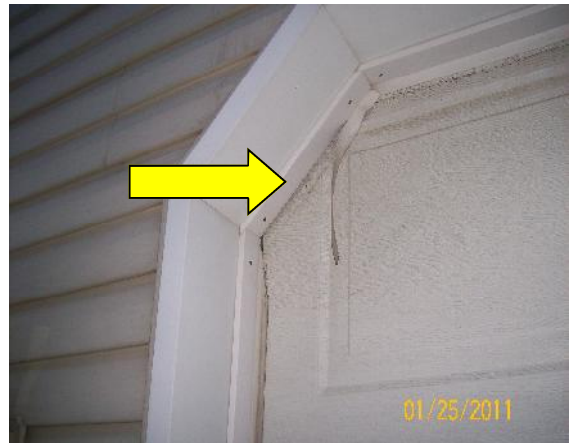
The trim around the garage should be repaired.

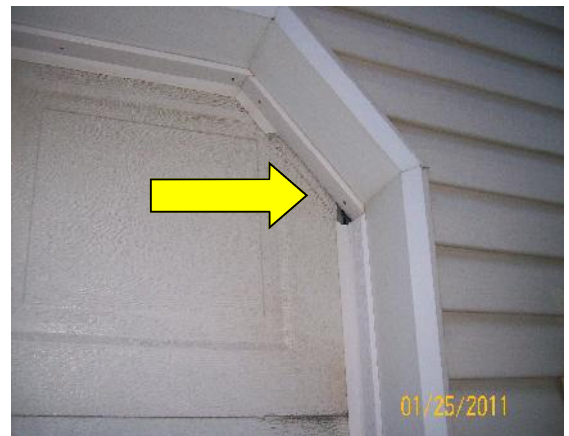
There are 2 section that need attention.

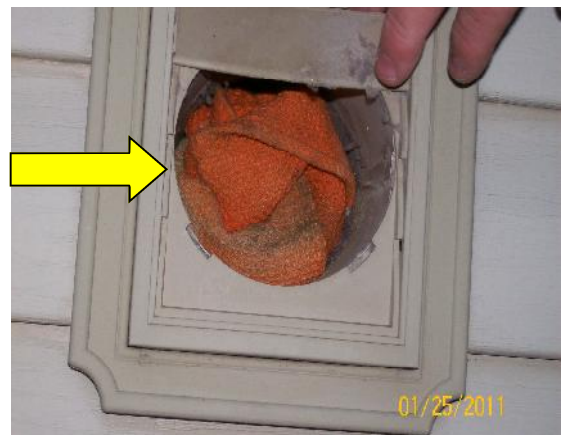
There are missing vents that cover the dryer exhaust. There is not a dryer attached hence the rag to stop the air flow.

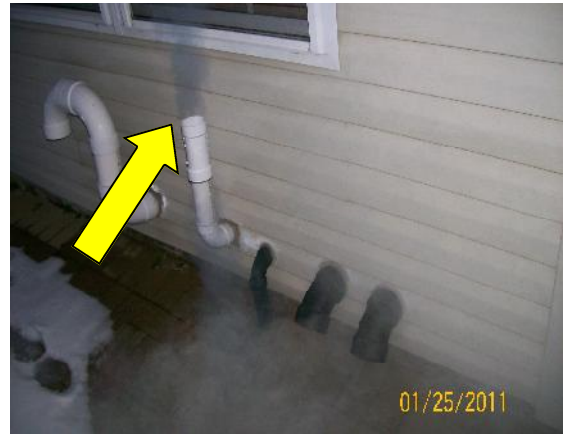
This is an unusual exhaust vent for the furnace. It causes excess water on the window above.

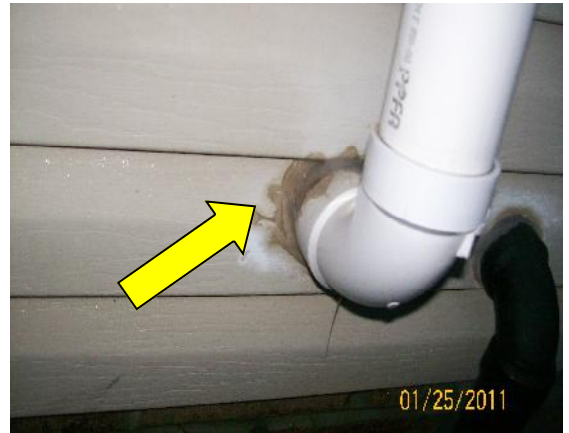
The caulking need to be maintained.

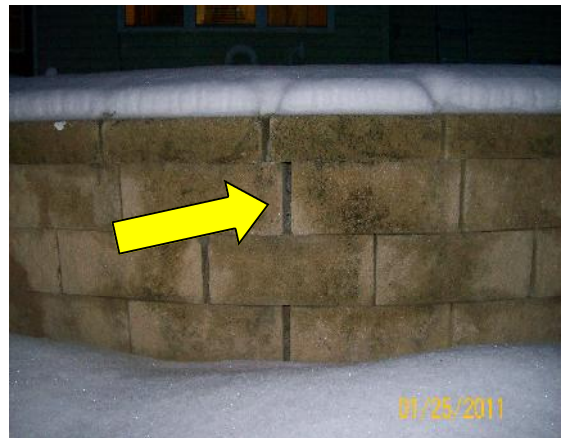
The block are separating and moving. This may cause further issues later. I would suggest repairing.

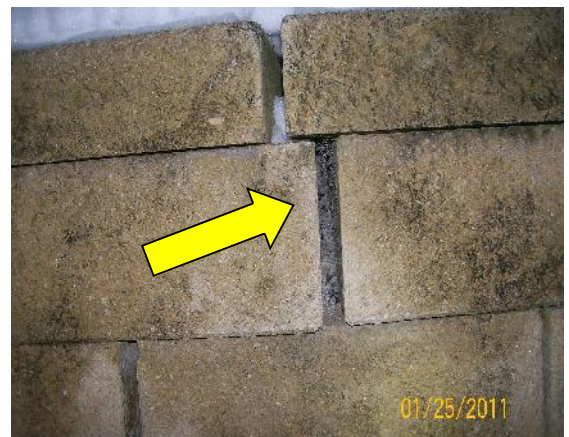
The Blocks appear not to have been secured. I also did not see a drain that would minimize water damage.

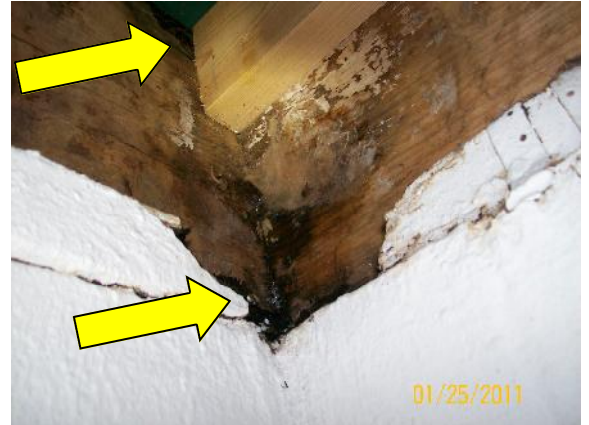
There significant water damage that needs to be repaired. This the header atop the block foundation walls. I recommend that a structural engineer review the home.

Please read the report carefully and note there are several areas of this home that need to attention. I would also recommend having a Mold Inspection and a Structural engineer to look at the foundation especially where the header is damaged and where the block is missing.

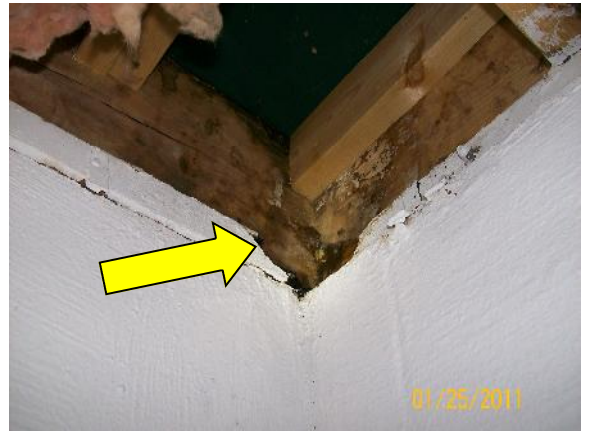
This is a second picture showing that the header is actually missing.

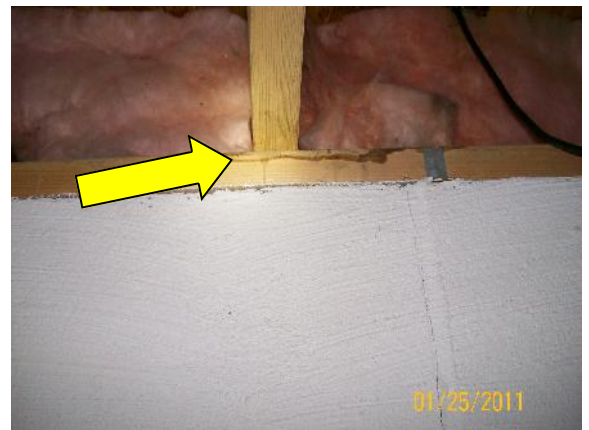
Here is some additional water damage on the header.

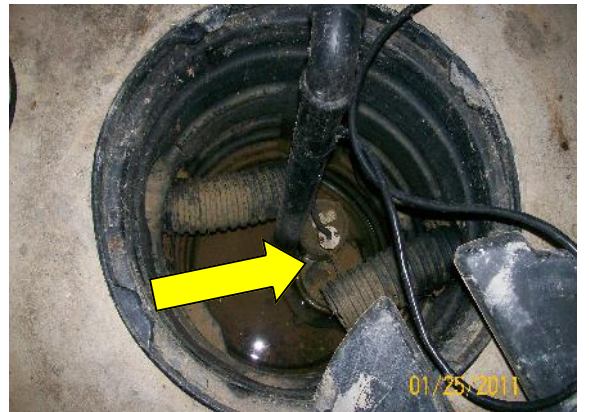
The sump pump is not working. This should also have a battery back up.

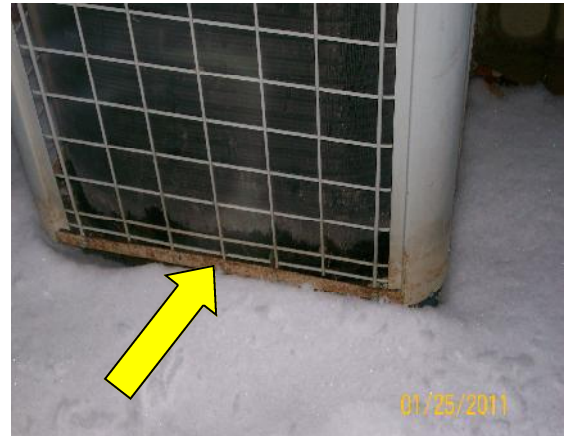
The AC unit was not able to be tested due to temp. There is significant rust on the unit and the fins at the bottom.

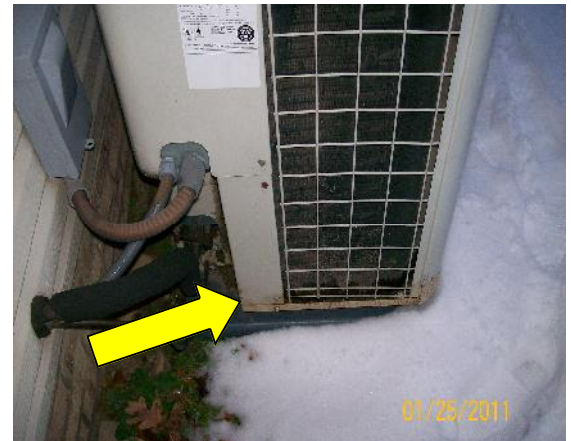
There is also rust on the bottom of the unit. Also the unit is not protected from the winter.

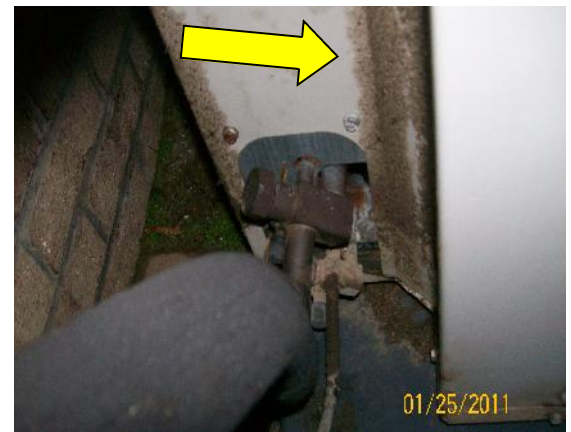
This appears to be oil based dirt. Could be a leak.

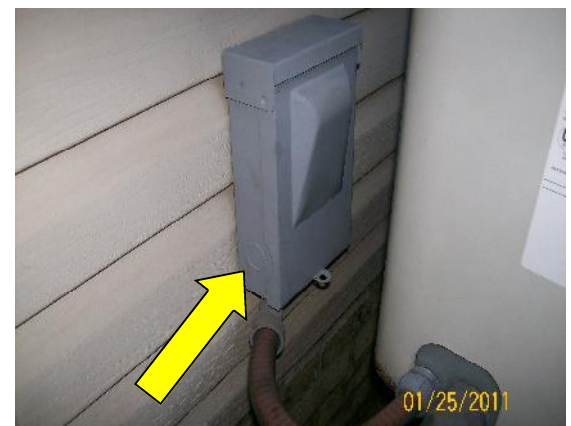
The electrical box was not able to be opened.

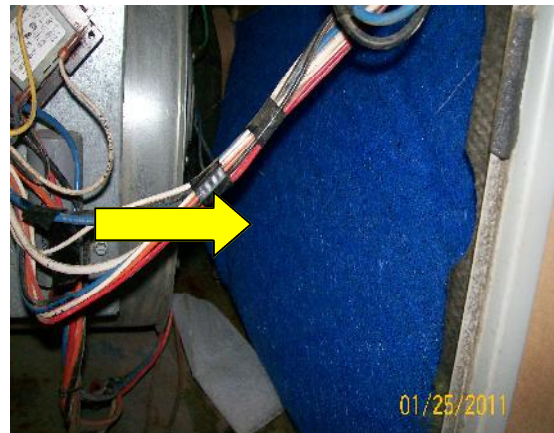
The air filter was not quality and should be replaced and attained. Also a dryer sheet as placed in the unit. I would assume to cover some smell.

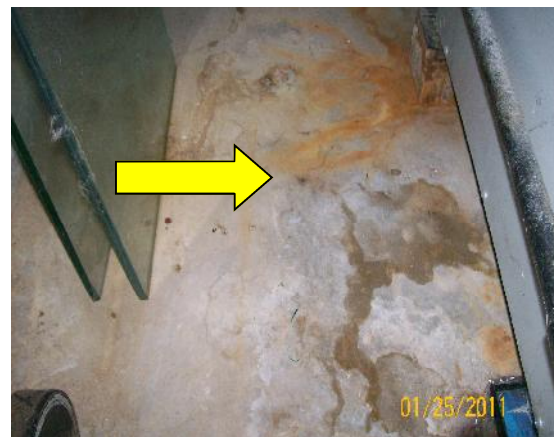
There was evidence of excess water from the furnace on to the floor.

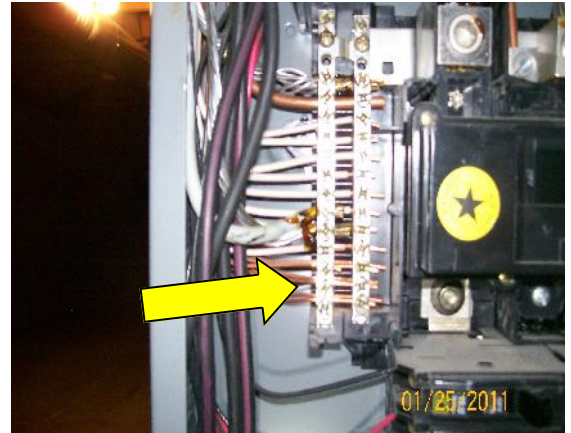
There are some double lugging. This is where that are two wires attached under one screw on the buss board.

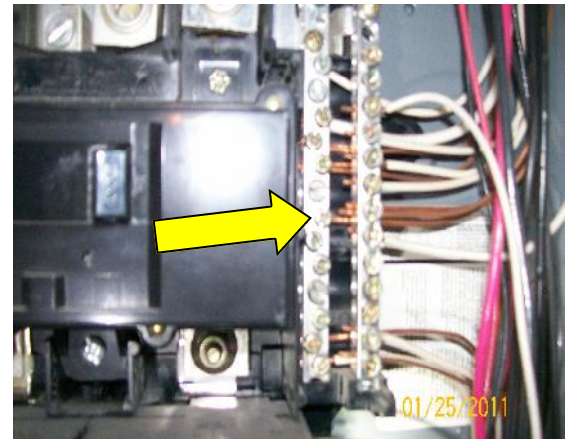
There are some double lugging. This is where that are two wires attached under one screw on the buss board.

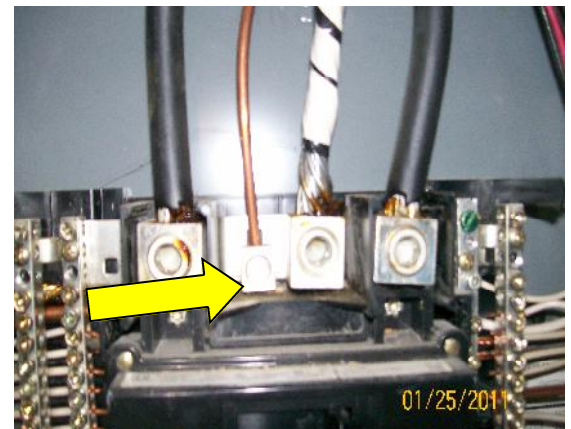
The main incoming wires appear to be in good condition.

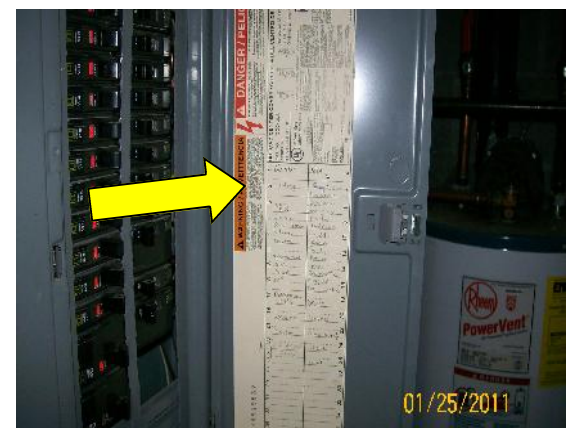
The breakers appeared to be labeled, this was not verified..

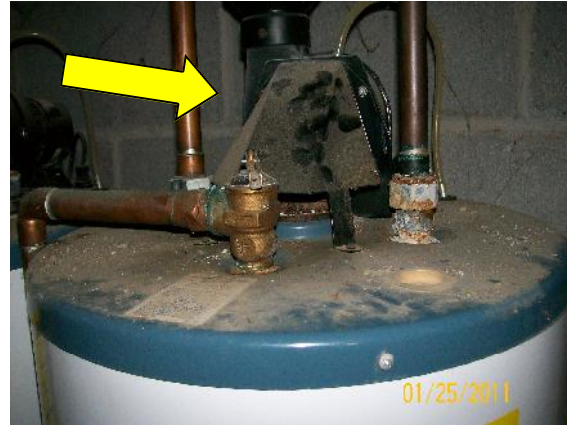
Both water heaters have active blower vents attached. The hot water heaters are not on.

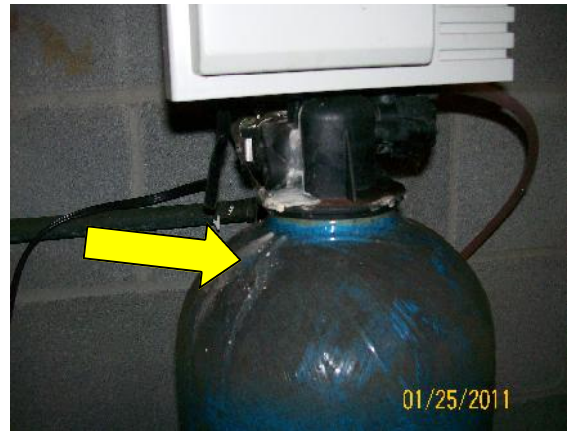
There appeared to be some black dust on the water softener tank.

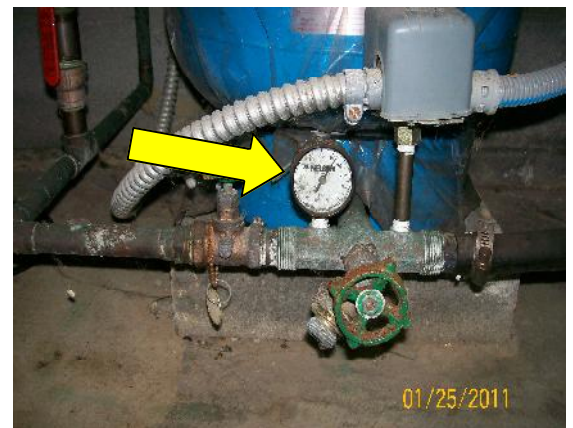
The house pressure was good at approx. 64 PSI.

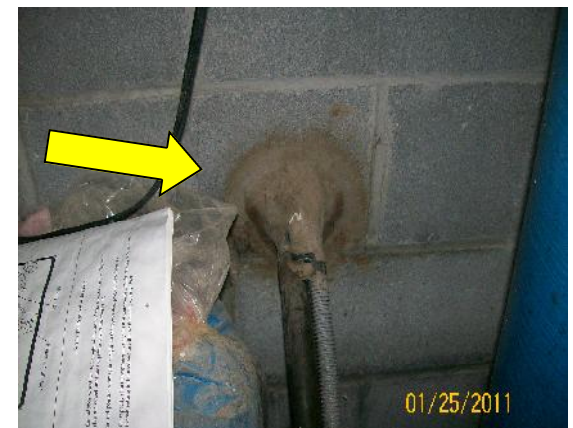
The incoming water line and electrical line to the water pump were cemented in to the wall.

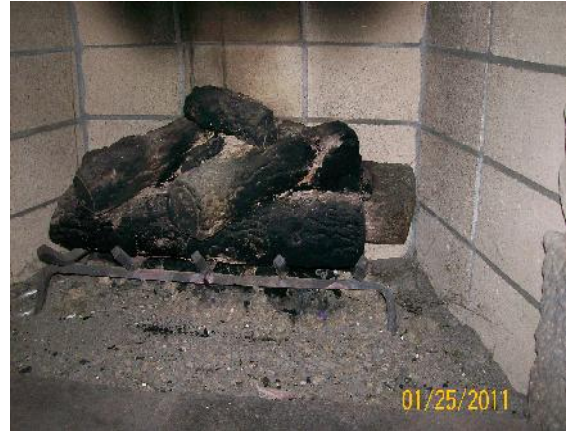
On Gas fire place has a lot of black ash or soot that I would not expect.

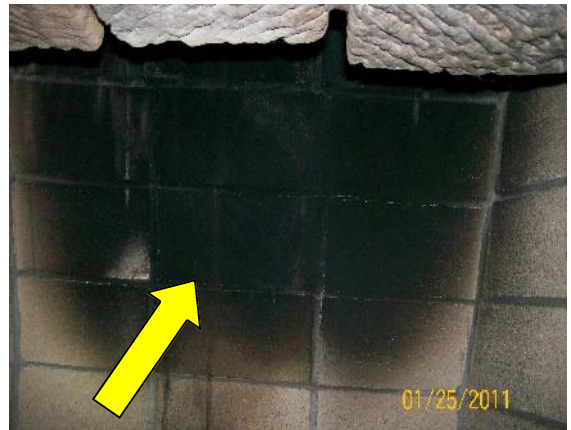
On Gas fire place has a lot of black ash or soot that I would not expect. This appears to say the gas logs are not burning correct. This should be checked replaced.

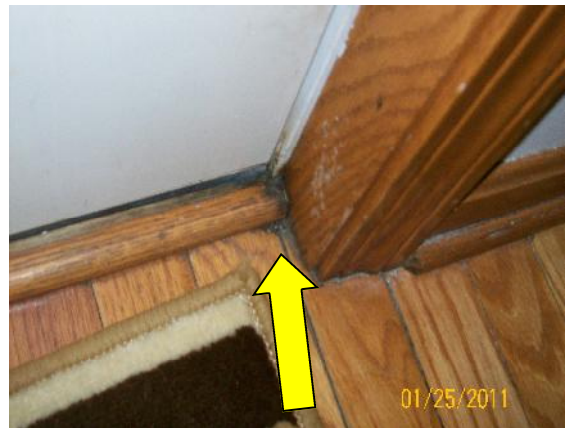
There is some water damage by the back door.

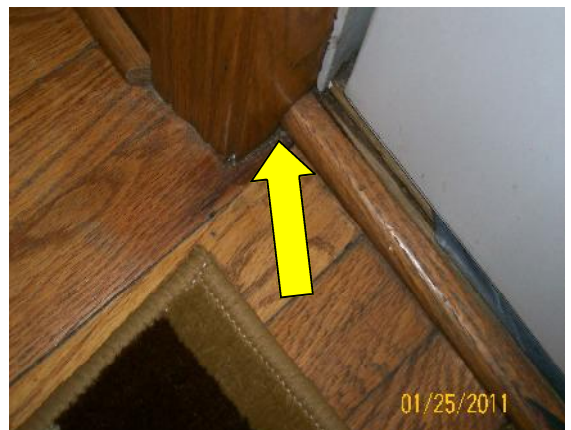
There is some water damage by the back door.

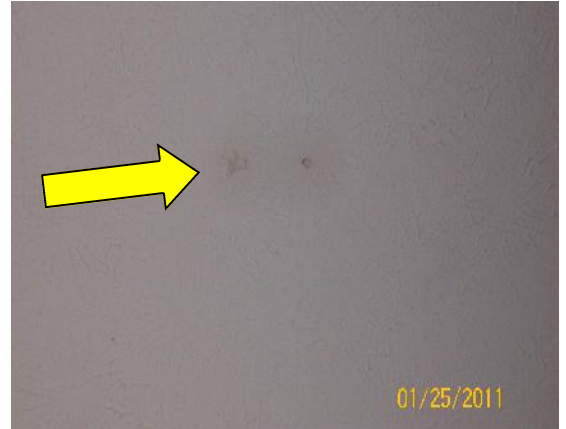
There are two dark spots on the ceiling that could not be identified.

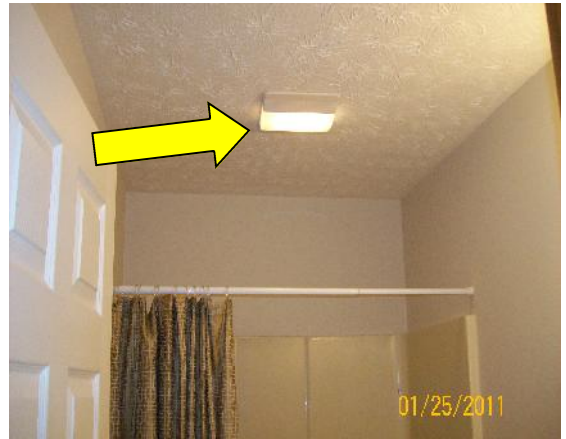
The bathrooms have vents that are working.

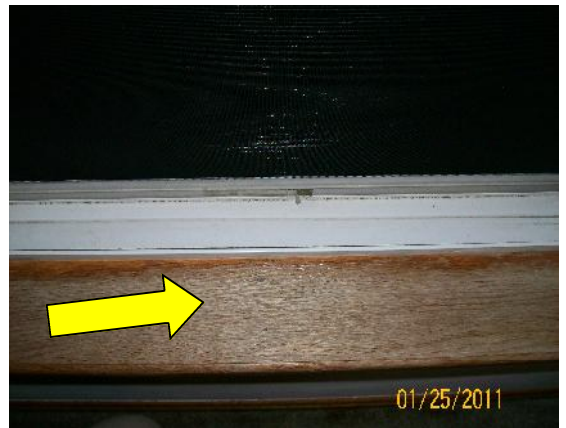
There is apparent water damage on the window sills.

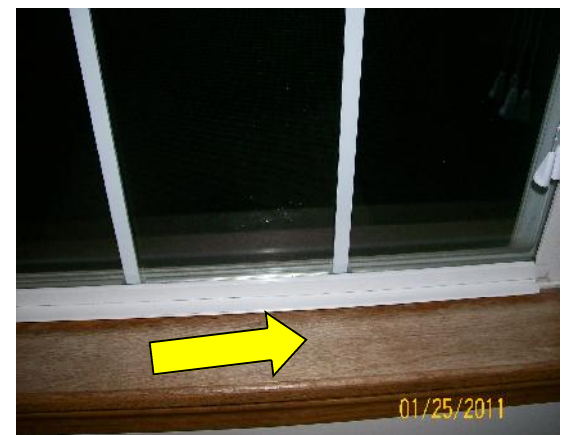
There is apparent water damage on the some of the second story window sills.

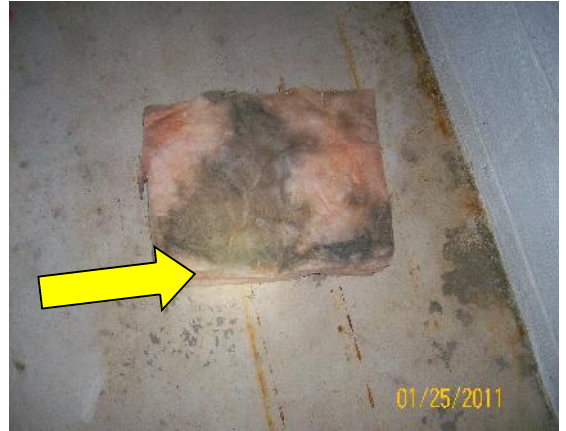
There is something that is on a section of insulation in the basement.

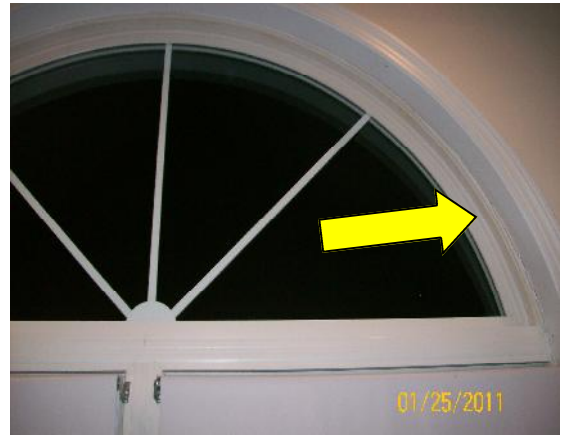
The window caulking should be resealed.

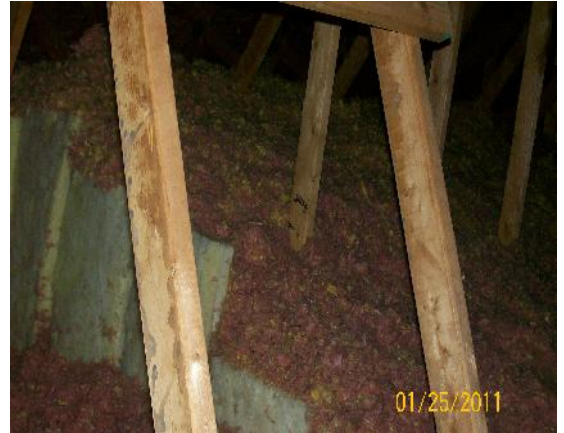
There is additional insulation covering the second floor room above the attic.

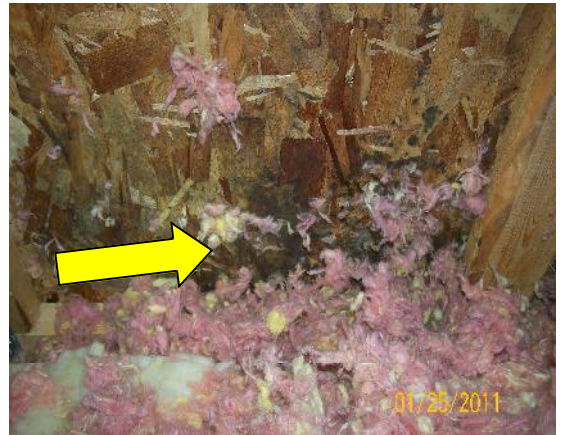
As I moved some of the insulation from the vertical exterior wall there is apparent mold growth. This should be tested and an mold inspection ordered.

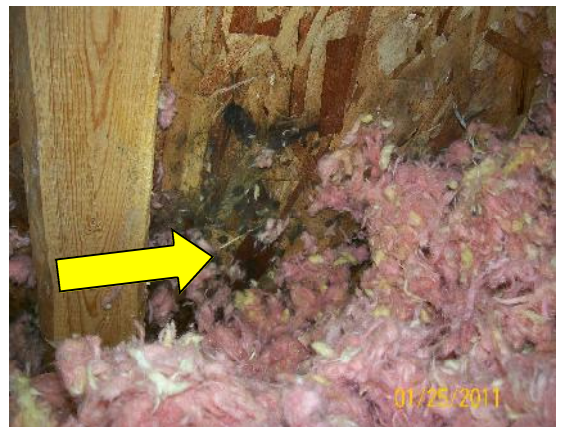
The apparent mold should be remediated.

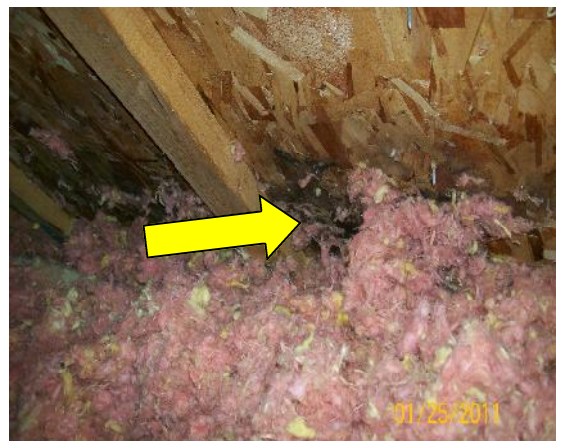
The section I found was approx. 3 feet by 2 feet, but my search was not exhaustive.
