Commercial Property Inspection

325 North Main Street
City, MA

January 26, 2012

Re: Commercial Property Inspection
325 North Main Street
City, MA

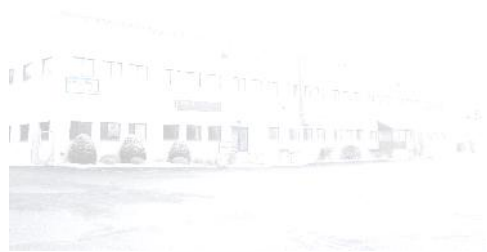
Subject property, front side
